River Restoration in Denmark

River Restoration in Denmark – 24 examples

Storstrøm County, Technical and Environmental Division 2006

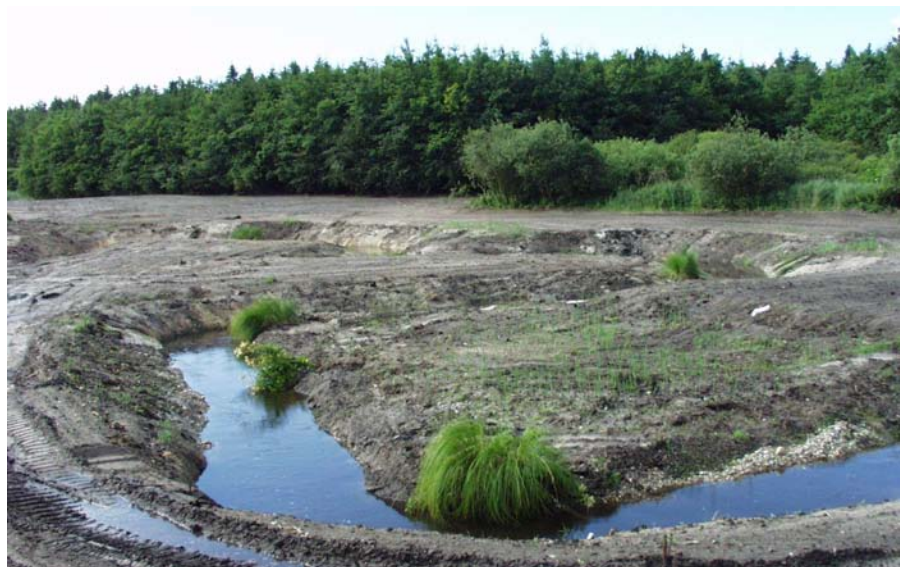
Digging the new meanders

When designing the new meanders we closely studied the natural meanders located upstream of the project area. Among other things we found out that the terrain along the inner side of the bends is generally much lower than on the outer side along a zone of up to 15 m wide. In contrast, the sides of both banks at river level were usually vertical. The principle of the new bends is shown in the photograph below.

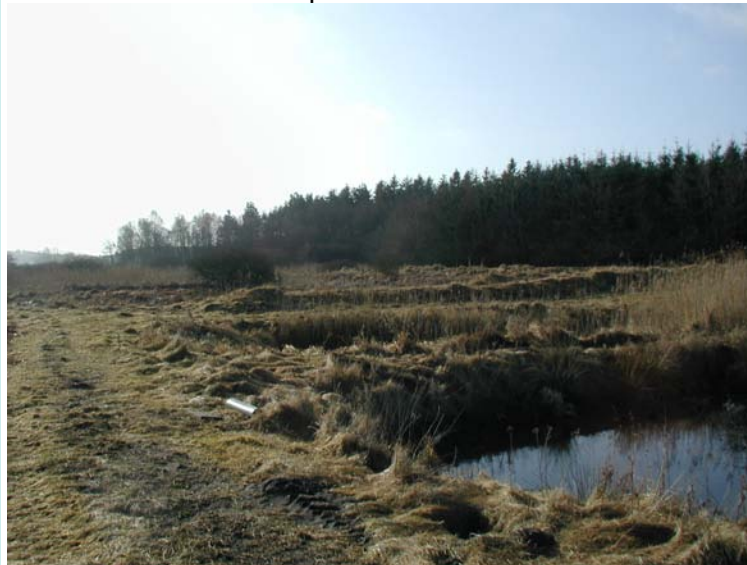
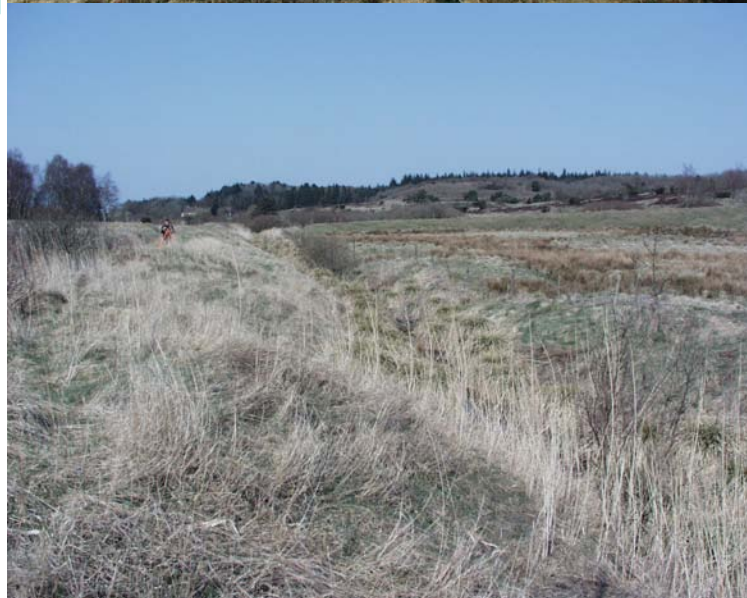
The photographs below show the fish farm and the embankment between the two rivers prior to restoration.

Prior to restoration

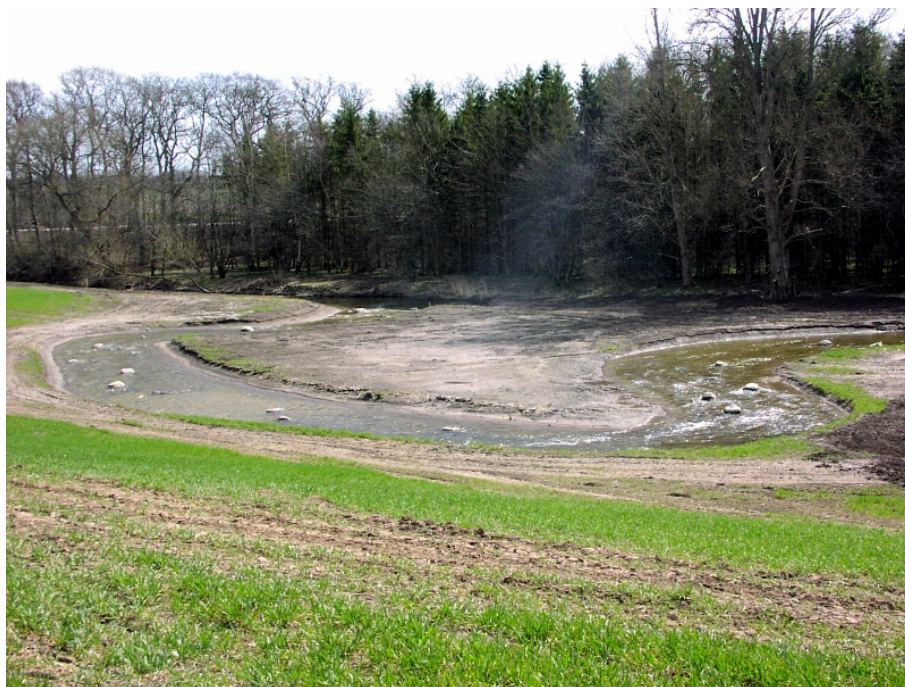
A new meander with a 3.5‰ slope

No marked erosion occurred even though the river flooded its banks and despite the fact that the earth filling lies on the outer side of a sharp bend that slopes 3.5‰. This is undoubtedly a method that will be used in future as it is both relatively cheap and more natural. River banks that only consist of large stones are not natural in Danish rivers. The soil is ordinary moraine soil.
